LITHIUM-ION BATTERY FIRES AND EMISSIONS CHARACTERIZATION

REPORT

November 2024

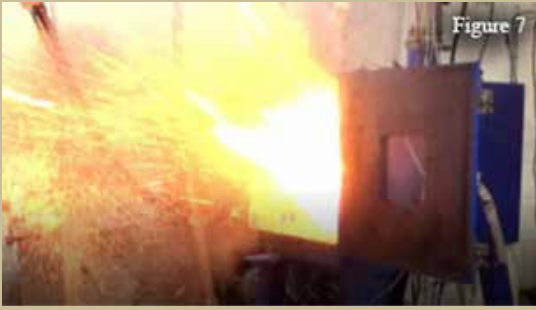
Figure 7 (Left): Battery Test #3, where internal pressure from Li battery thermal runaway forced the blast chamber door to open.

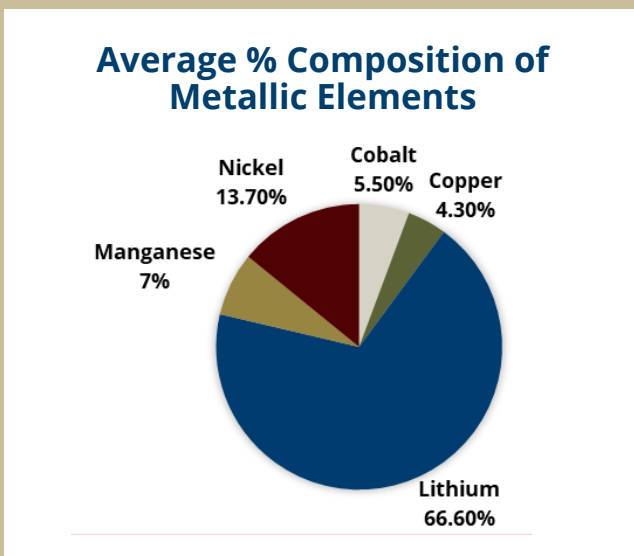
Figure 9: Composition of Metallic Elements

- o The PM_{2.5} collection was dominated by metallic elements with a small fraction of soot. Dominant elements were lithium, followed by nickel, manganese and cobalt.
